F-III A WING FATIGUE TEST PROGRAM

*EXPERIMENTAL BRANCH
STRUCTURES DIVISION*

APRIL 1976

TECHNICAL REPORT AFFDL-TR-76-30
FINAL REPORT FOR PERIOD 24 MARCH 71 - 10 JULY 74

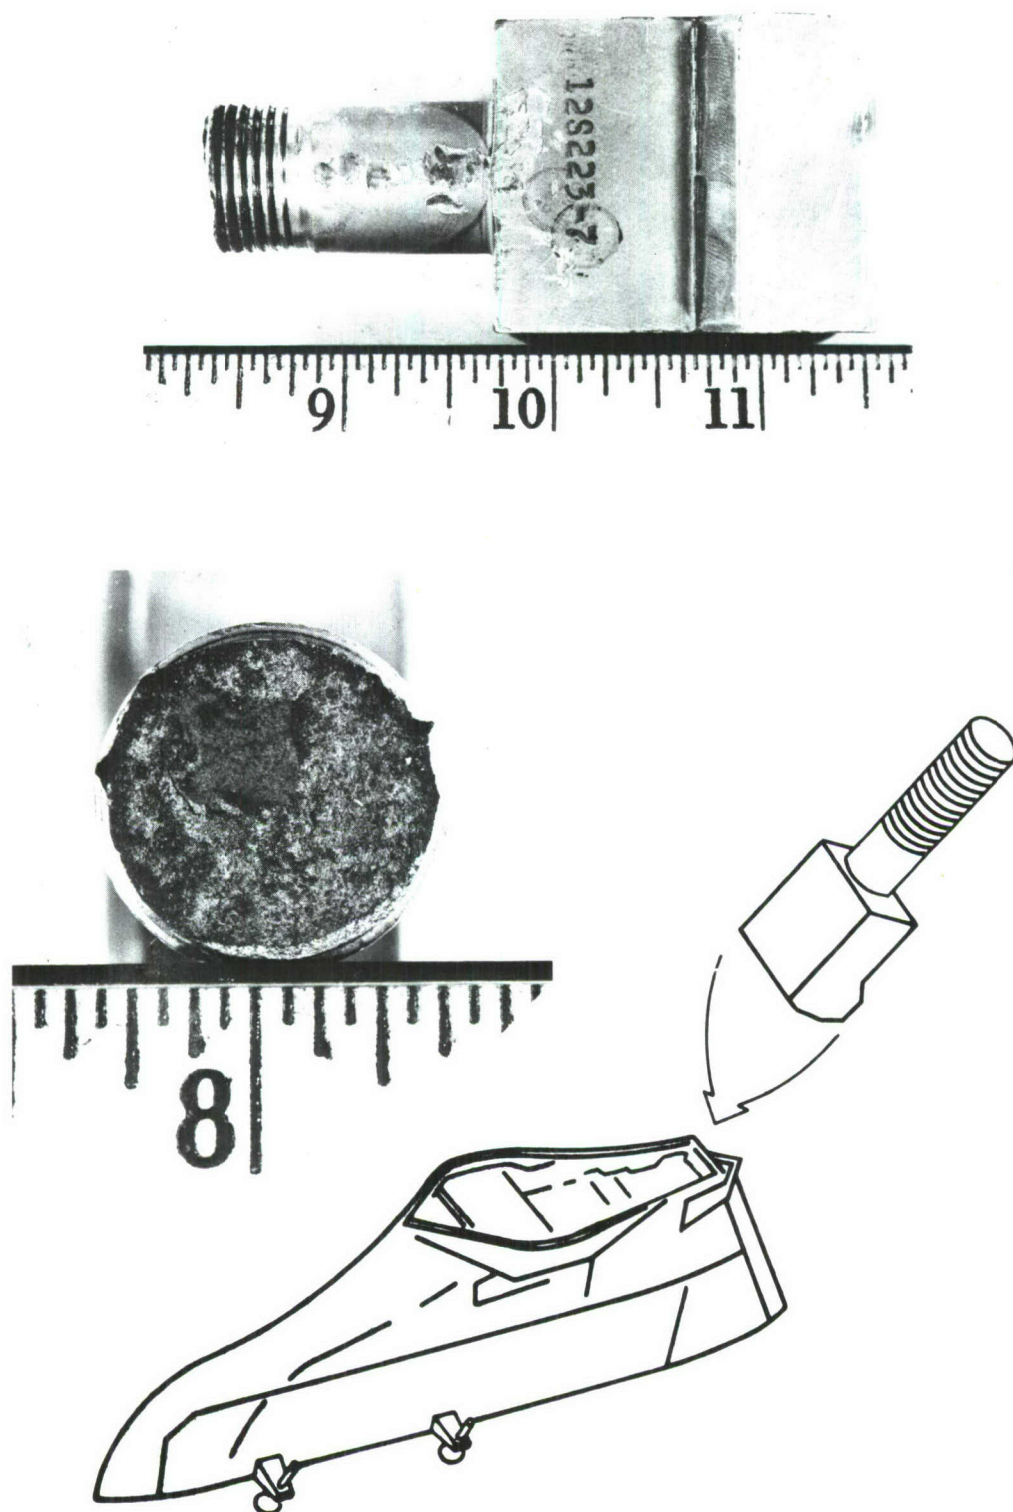
Figure 11. Aft Pylon Attach Bolt Failure

The aft pylon attachment bolt of the outboard fixed pylon failed at 95 percent of the first fatigue lifetime (Figure 11). The fracture occurred in the threaded portion of the attachment bolt. A metallurgical evaluation was conducted by Mr. Alan Gunderson of the Air Force Materials Laboratory to determine the cause and mode of failure. Based on the predominant intergranular fracture, longtime to failure after loading, and the deep crevices between grains, it was concluded that stress corrosion cracking was the primary cause of failure.

The pylon attachment bolt's original heat treat of 260-280 ksi was changed to 200-220 ksi to reduce the susceptibility to stress corrosion cracking and the machining of the threads was changed to rolled threads. After these changes, a satisfactory fatigue life was obtained.

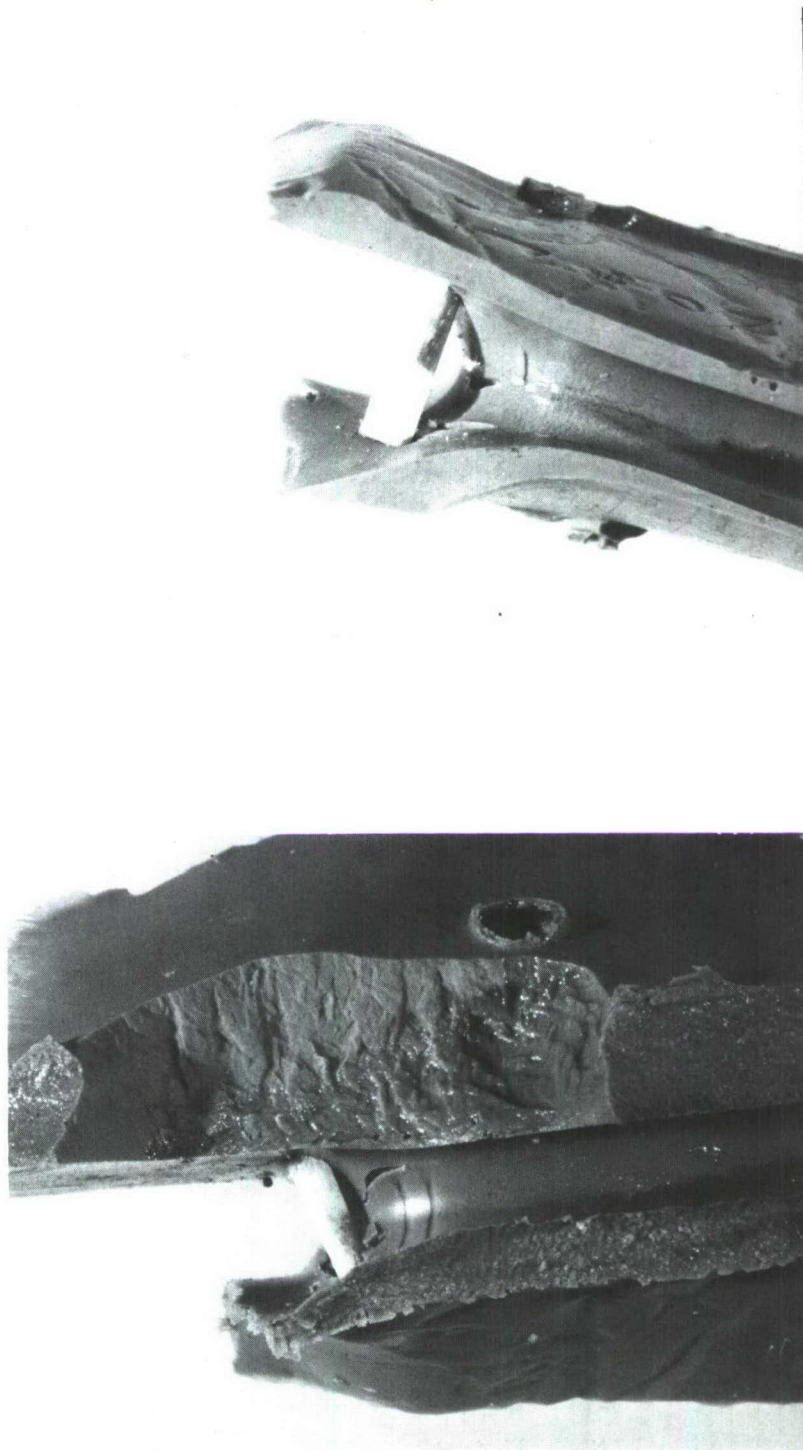
Figure 13. Magnetic Rubber Casts

A crack in upper surface fuel flow hole No. 13 was discovered at the end of the first fatigue life. The crack was in the compression surface of the wing (top) and was caused by the large compressive stress (above yield) creating a high tension residual stress in the fuel flow hole. The theory of this type of crack propagation is explained in "The Load Interaction and Sequence on the Fatigue Behavior of Notched Coupons," ASTM STP519 pp 109-132, by J.M. Potter. This crack was polished out after the first life and again after the second life. The crack history is plotted in Figure 12. This plot was generated from magnetic rubber casts taken throughout the program. Typical casts are presented in Figure 13 and 14.
